# Product Support Bulletin

Subject: Proper Method for Running Benchmark and Diagnostics Programs

PSB No: S-0158

# HDD Controller WD1002A-WX1 (8-bit)

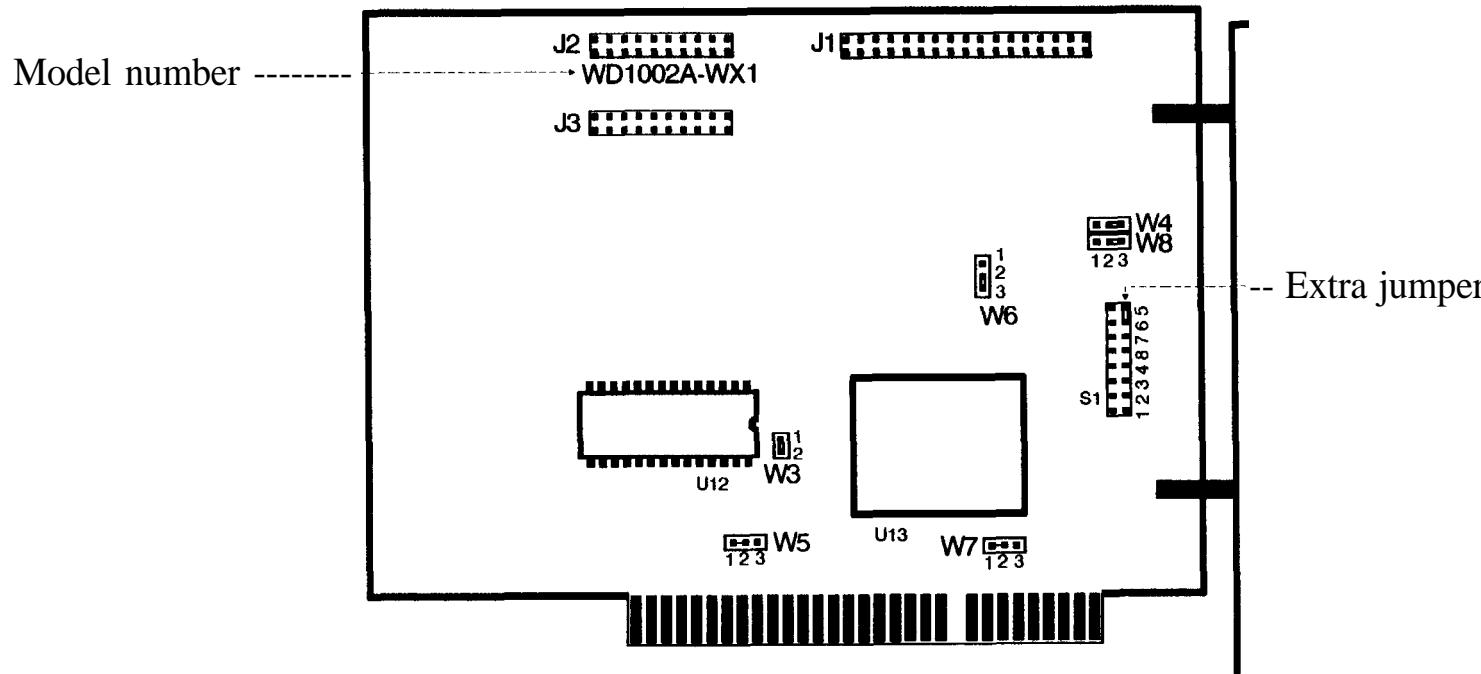
## FACTORY SETTINGS

Jumper	Position	Description
W1	N/A	Not used.
W2	N/A	Not used.
<b>W3</b>	1 to 2	BIOS ROM is enabled (on controller).
W4	2 to 3	Device address 320H.
W5	* hard-wired 1 to 2	BIOS ROM size (32K or 64K).
W6	2 to 3	Reduced write current (< = 8 heads).
W7	* hard-wired 1 to 2	IRQ 5.
W8	2 to 3	Disk controller I. D. (set to be the first).

\* No jumper pins - 1 and 2 are connected by a PCB board etch.

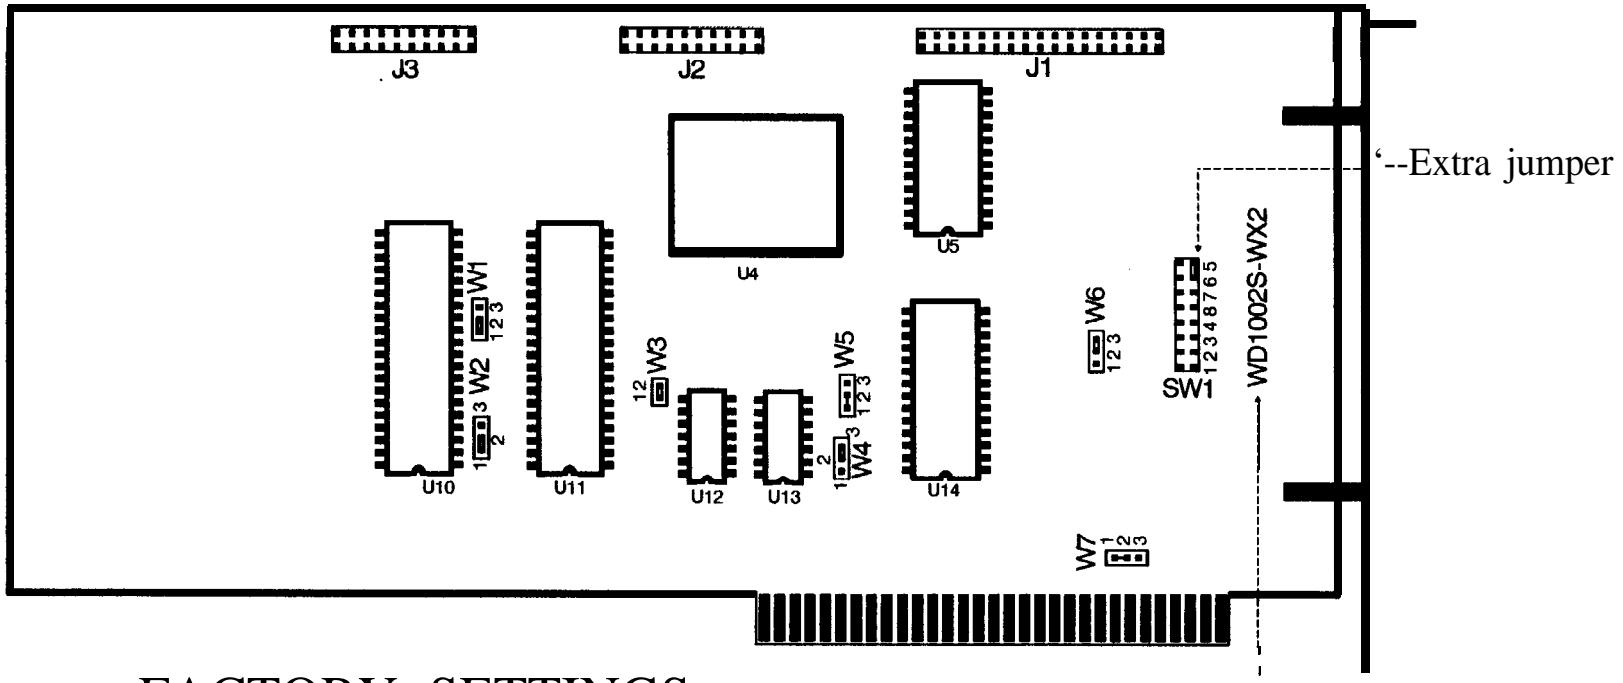
# HDD Controller WD1002S-WX2 (8-bit)

## FACTORY SETTINGS

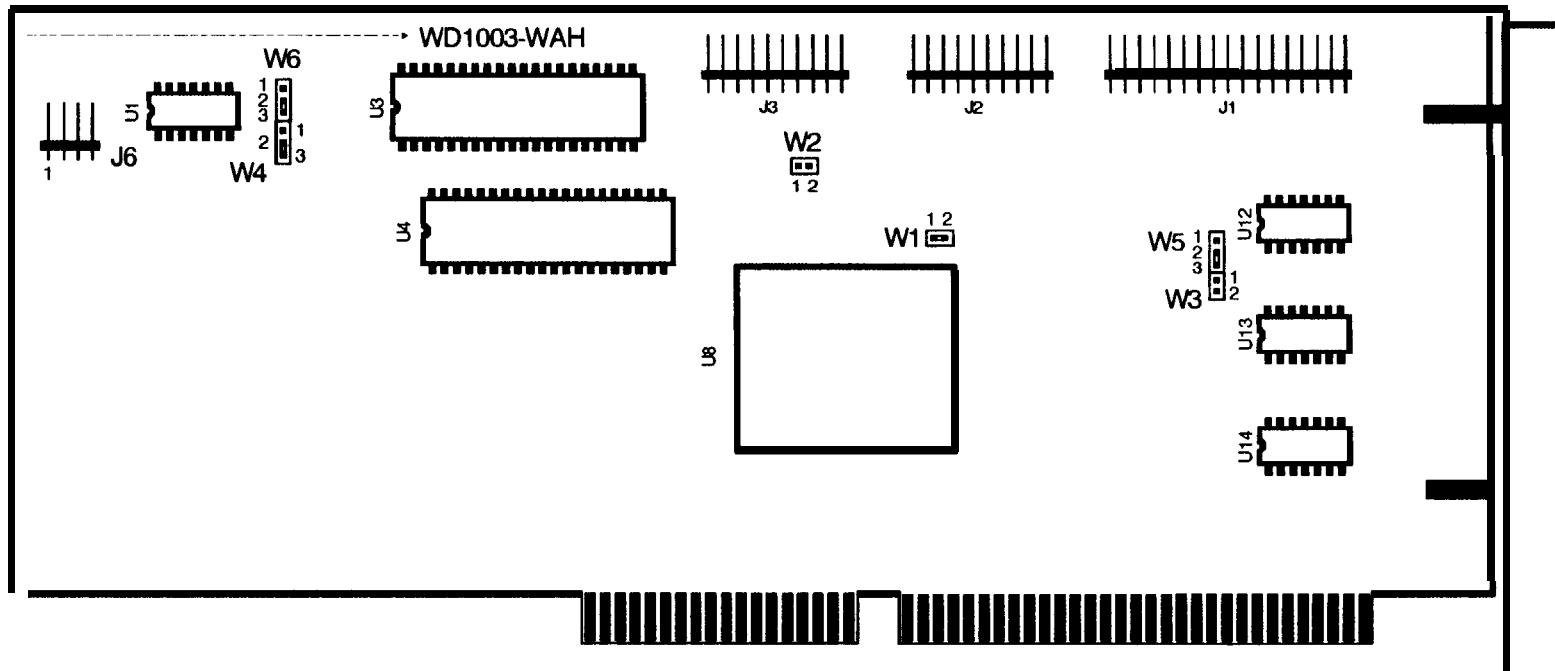
# HDD Controller WD1003-WAH (16-bit)

## FACTORY SETTINGS

Jumper	Position	Description
W1	1 to 2	Status read is latched.
W2	No jumper	Primary address selected.
W3	* No jumper	Required for this configuration.
W4	2 to 3	Required for this configuration.
W5	2 to 3	Standard configuration.
W6	2 to 3	Standard configuration.

\* No jumper pins.

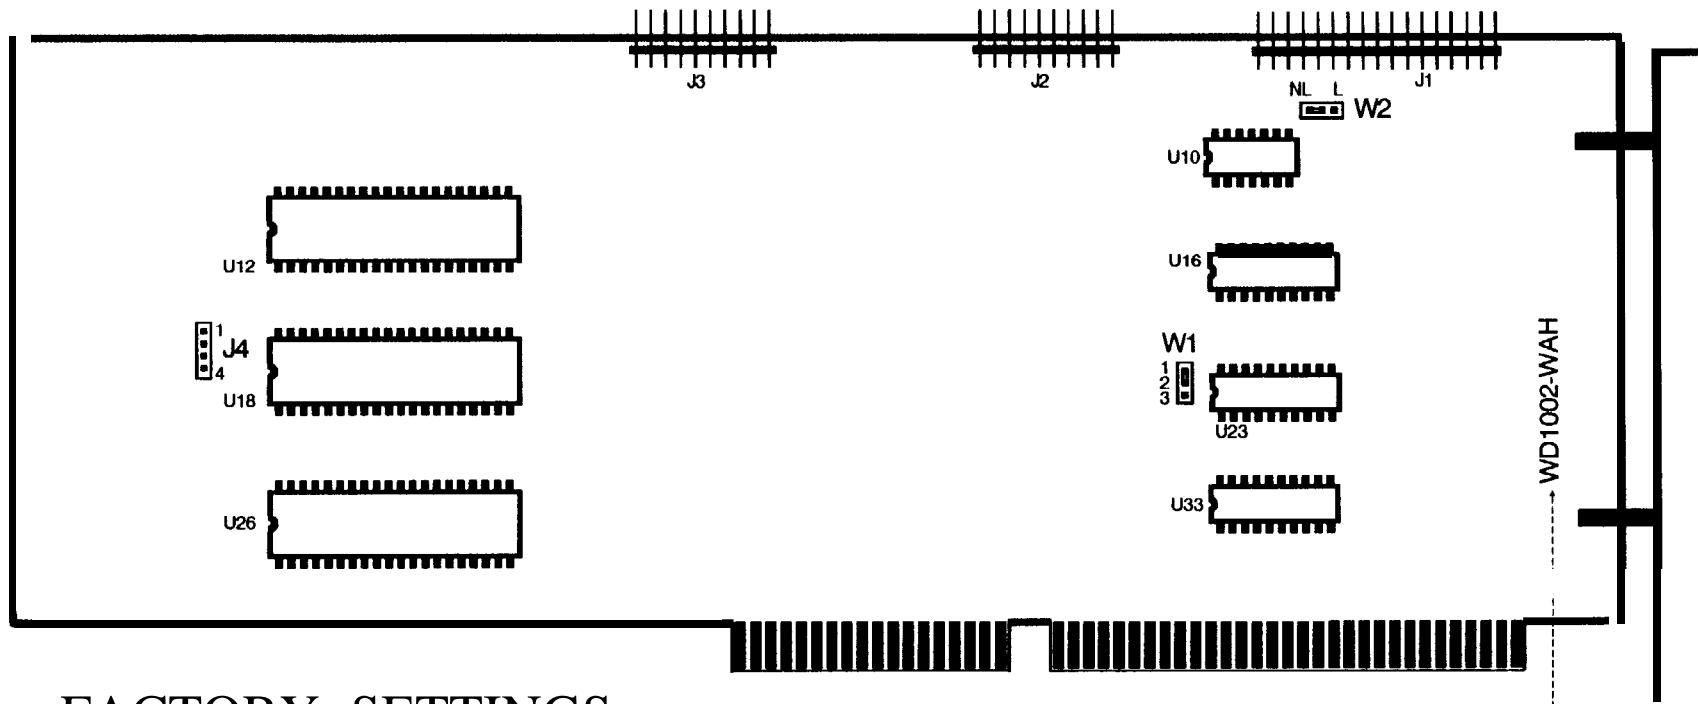
# HDD Controller WD1002-WAH (16-bit)

## FACTORY SETTINGS

Model	<u>Pin 1 of J4</u>
Equity III	Orange wire
Equity II +	Blue wire
Equity III +	Red wire

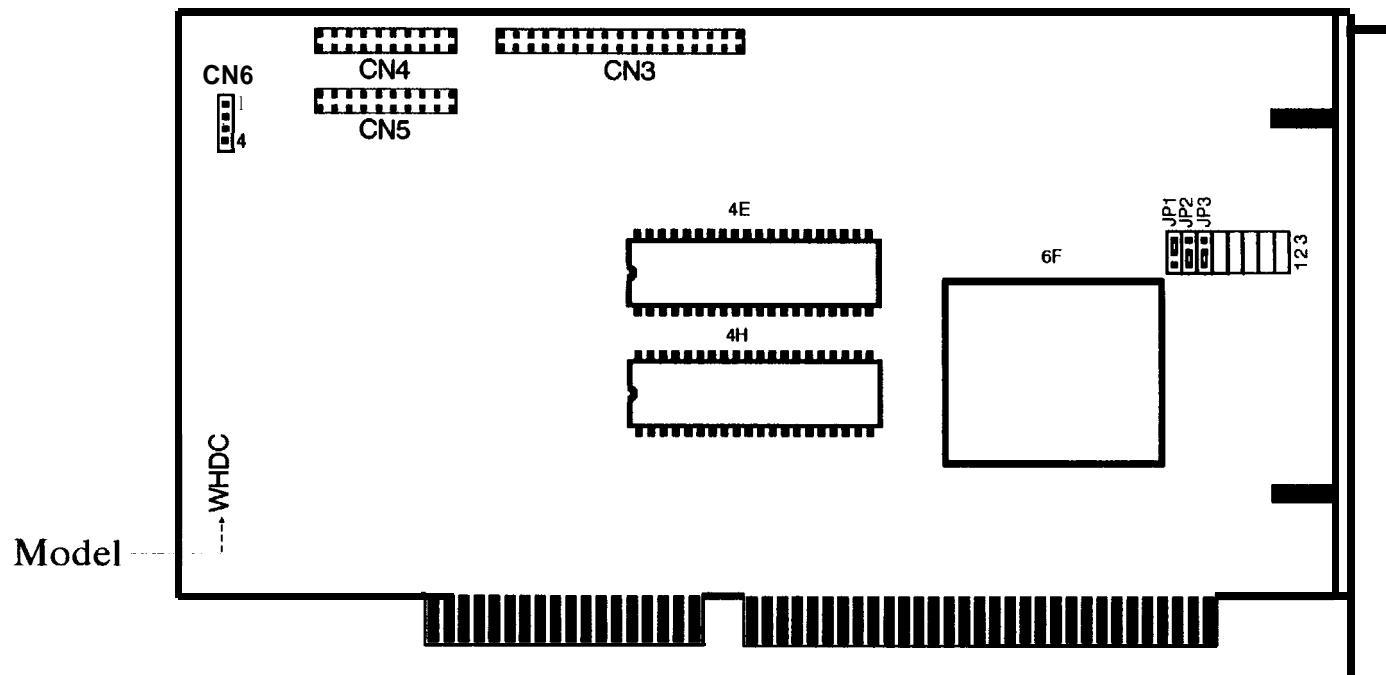
# HDD Controller WHDC (16-bit)

## FACTORY SETTINGS

Jumper	Position	Description
* JP1 (J1)	*2 to 3 (B to C)	Primary address selected.
* JP2 (J2)	* 1 to 2 (A to B)	Status read is non-latched (select = drive busy).
* JP3 (J3)	* 1 to 2 (A to B)	WAH mode (dual HDD controller).
JP4 to JP8	No jumper pins.	Hardwired to factory settings.

\* "JP" may labeled as "J", "1" as "A", "2" as "B" and "3" as "C".

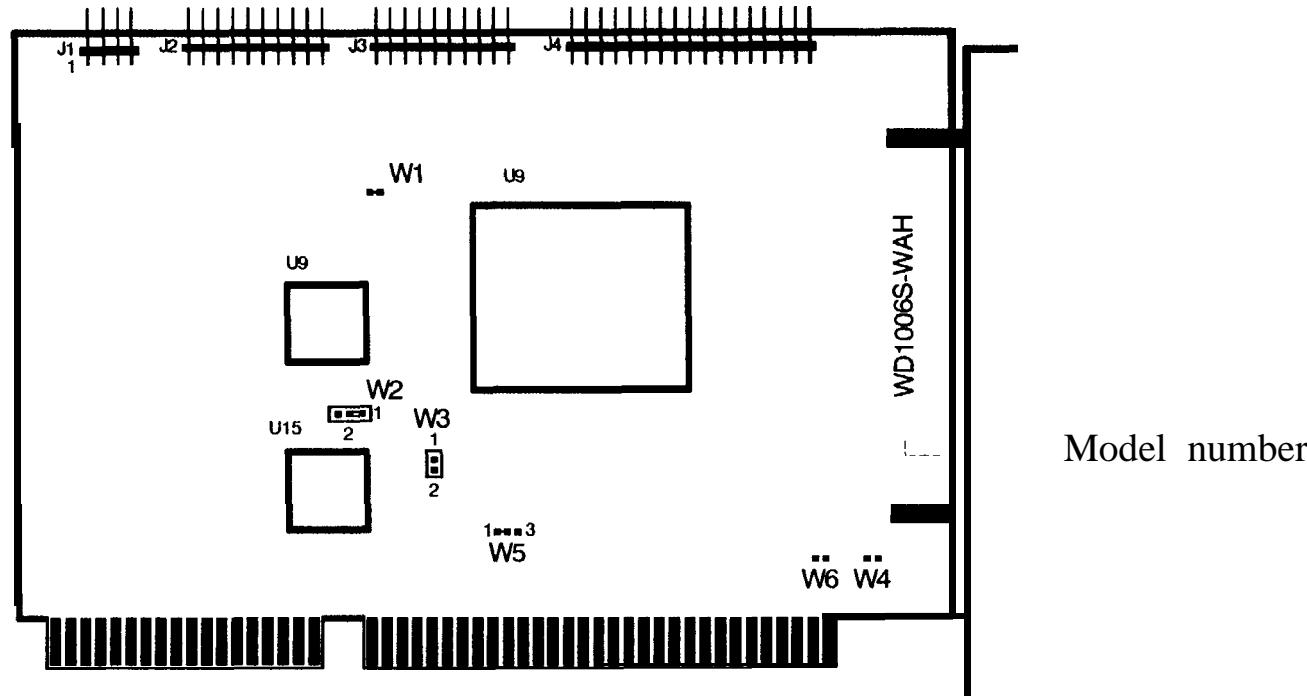
# HDD Controller WD1006S-WAH (16-bit)

## FACTORY SETTINGS

Jumper	Position	Description	Model	Pin 1 of J1
W1	* 1 to 2	LED lights for drive selection (non- latched).	Equity 386/20	Red wire
W2	1 to 2	No reduced write current,		
W3	No jumper	Enables cacheing.		
W4	* No jumper	Isolates mounting bracket from logic ground.		
W5	* 1 to 2	Primary controller port.		
W6	* No jumper	Non-latched mode.

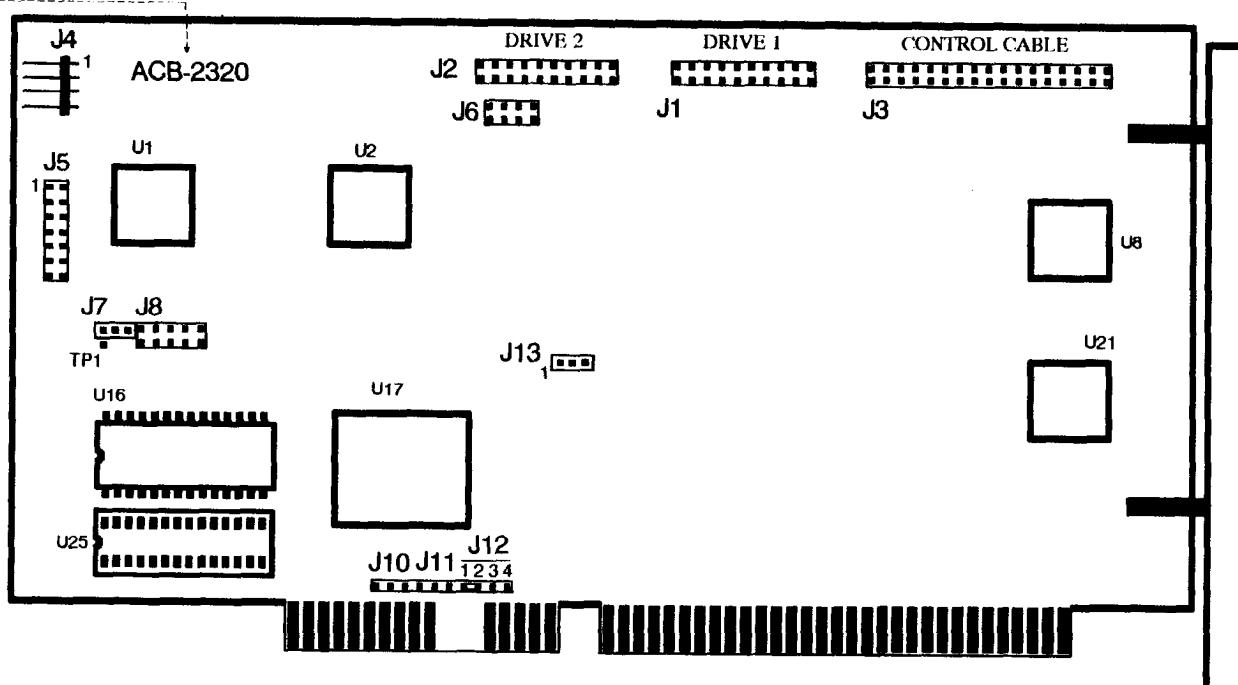
# HDD Controller ACB-2320 (16-bit)

## FACTORY SETTINGS

## Connection of LED indicator cable :
